# FY 2017 CYPRESS CREEK BASIN HIGHLIGHTS REPORT

*Texas Clean Rivers Program*

## Executive Summary

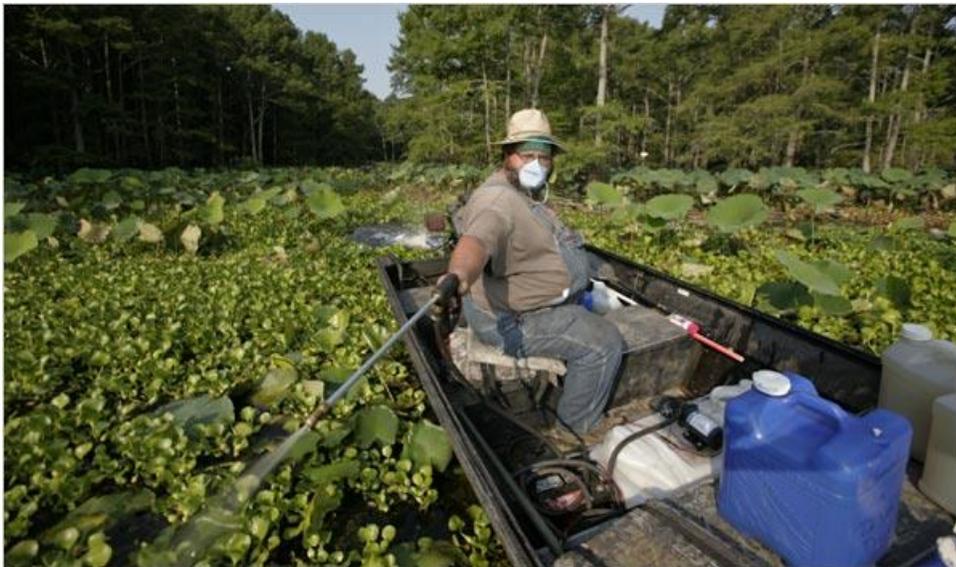
Figure 15: Herbicide Application in Caddo Lake

Giant salvinia, water hyacinth, hydrilla, and crested floating heart are the primary species of concern at Caddo Lake. Giant salvinia has been the priority for invasive species management. There were 4,943 acres of giant salvinia observed during the September 2016 Caddo Lake aquatic vegetation survey. This is an increase from the 2,840 acres observed in September 2015. Herbicide contractors sprayed over 4,200 acres of giant salvinia in 2016. Texas Parks and Wildlife Department (TPWD) released 263,400 adult giant salvinia weevils in Caddo. An additional 146,500 weevils were released by the Caddo Biocontrol Alliance. Water hyacinth and hydrilla did not require any treatment on Caddo Lake in 2016. First discovered in 2014, crested floating heart has been monitored and effectively treated with herbicide in 2016. Further monitoring of crested floating heart locations and herbicide treatment will be necessary in the future.

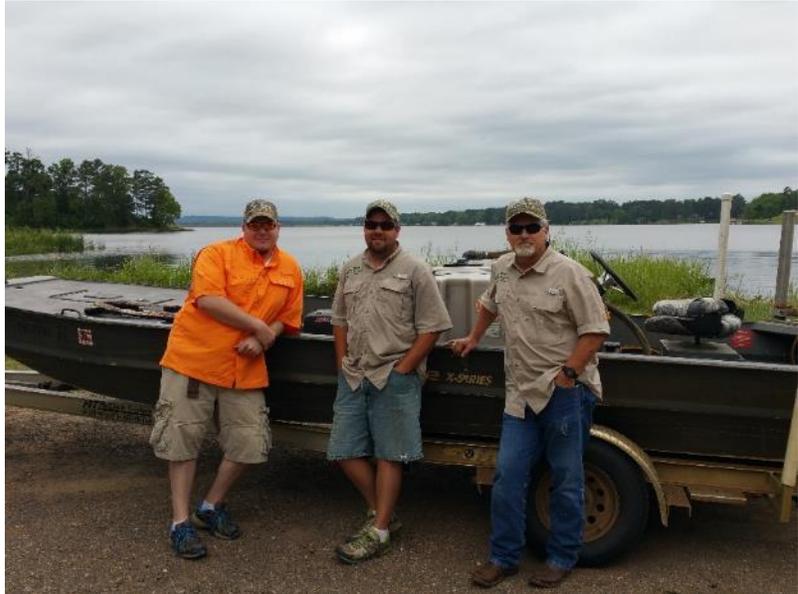
Figure 16: Company Contracted to Treat the Hydrilla Infestation

Hydrilla coverage was reduced from 38 acres in 2015 to 4 acres in 2016. This is a result of a shoreline homeowner group that organized to hire a contractor to conduct herbicide treatment of hydrilla in the reservoir. Water hyacinth was discovered by TPWD during their routine aquatic invasive species survey. Plants were removed by hand and treated with herbicide in hopes of eradication. TPWD met with concerned lake homeowners to discuss the

Sandy Duke, NETMWD Board of Director, was instrumental in organizing the homeowners group. A company was contracted to treat 37 acres on the Lone Star Side of the reservoir at a cost of \$995 per acre. Hydrilla was mainly located under the surface of the lake this year except in shallow spots where it could be seen floating to top of the water. The treatment was a success and rid the area of Hydrilla.

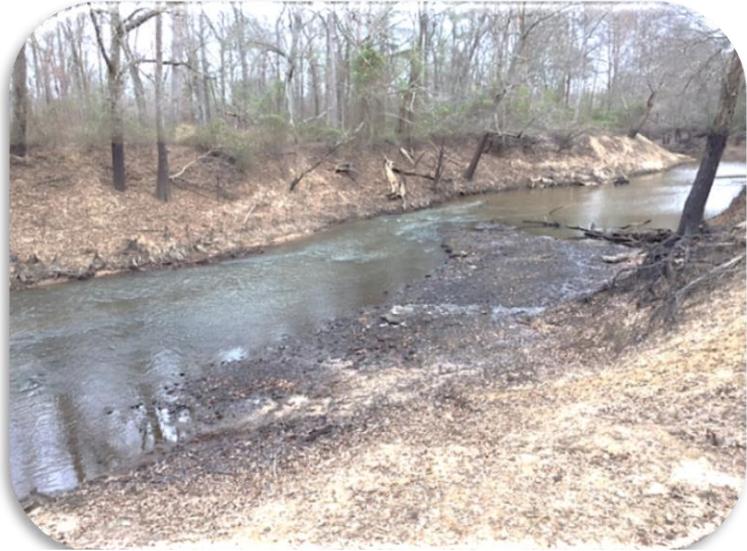
Figure 21: Shale outcropping at Sanders Oxbow

While on a site visit to the Sanders Oxbow to identify spawning bars, a shale outcropping with gravel at the opening to the oxbow was observed. The field trip was made while the gates at Lake O' the Pines were open to release 6 cubic feet per second (cfs) of water. Leakage at the gates was noticed and around 30 cfs was measured downstream of the dam.

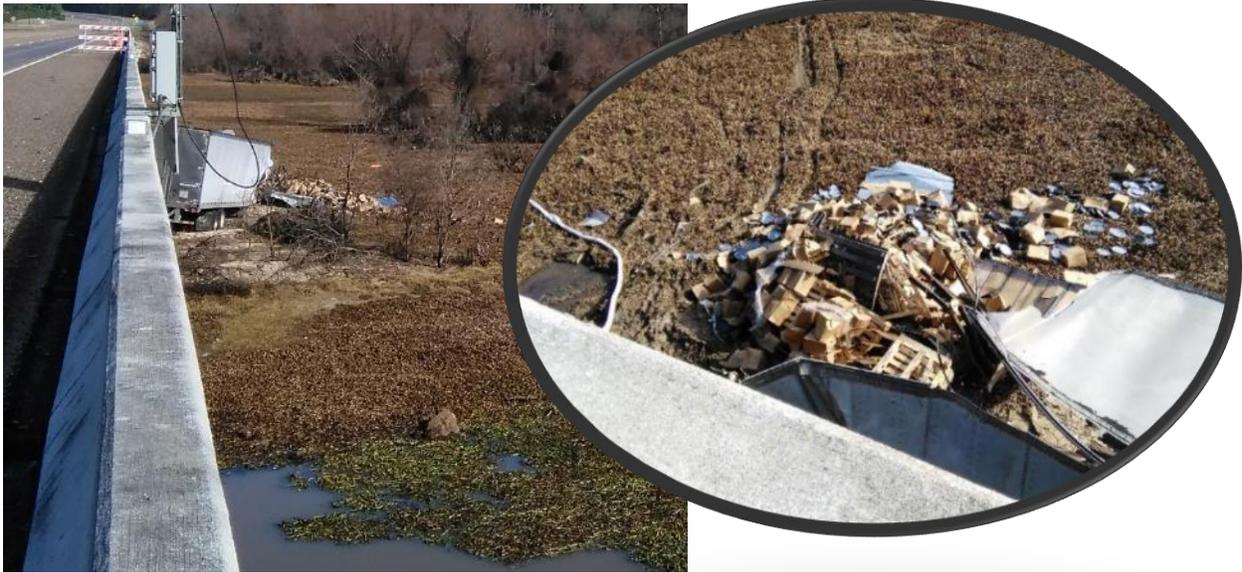
Figure 22: Truck accident on US259 at Lone Star

An accident occurred on December 23, 2016 on the US 259 bridge at Lone Star involving a truck and trailer which broke through the concrete railing, stopping at the headwaters of Lake O' the Pines. USACE, TCEQ and TXDOT oversaw the accident cleanup. The cargo appeared to be mostly unused lids for 5 gallon pails. About 100 gallons of diesel fuel spilled from the truck's fuel tanks. Most of the fuel soaked into the mud beside the main stream channel. Due to the location of the wreck, the contaminated soil was not removed.

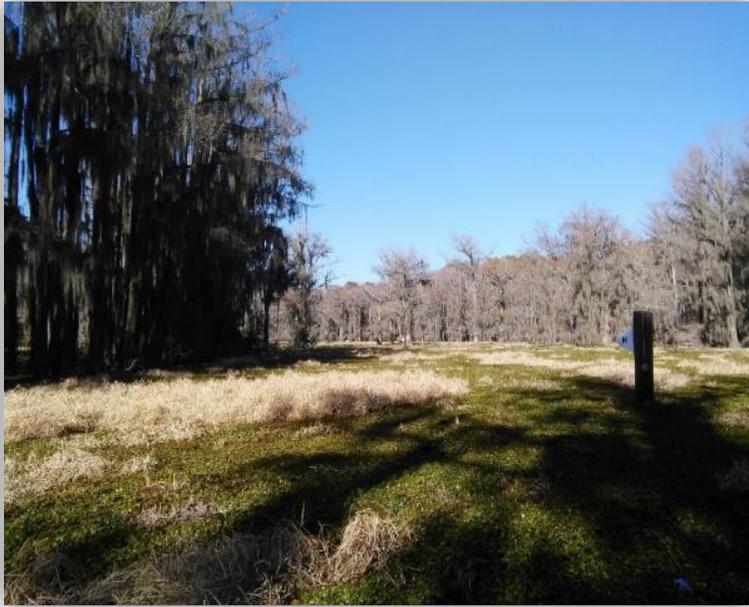
Figure 23: Giant Salvinia in Carters Lake area of Caddo Lake

After a large storm event in December 2015, heavy stream flow caused a thick mat of Giant Salvinia to accumulate into the Carters Lake area of Caddo Lake. The salvinia amassed at a bottleneck of trees along Boat Road R and piled into mats in excess of 1 foot thick. The mats were virtually impenetrable even by mud boat.

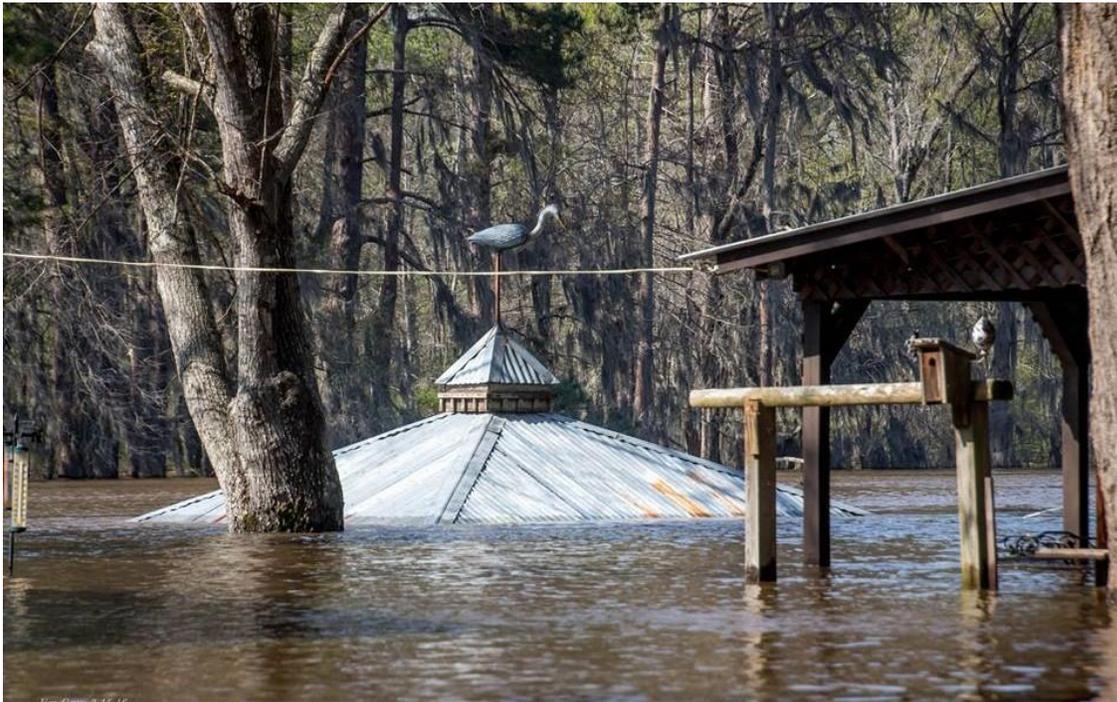
Figure 30: Flooding around Caddo Lake

Extensive flooding of the area around Caddo Lake occurred in March 2016. The peak level occurred on March 15 at 180.03 feet MSL (Mean Sea Level). This was the highest crest since 1966. Caddo Lake impounds about 27,000 surface acres of water when the level is at 168.5 feet MSL, which is the lake level when water will begin to flow over the spillway at Mooringsport. When Caddo crested at 180.03 feet, almost 53,000 surface acres were inundated. Caddo Lake storage capacity at 168.5 feet is approximately 147,000 acre-feet. By August 2016, 3,432,772 acre-feet flowed over the spillway. This was enough water to fill Caddo Lake more than 23 times!

While there is a regional perception that much of the Caddo Lake flooding was caused by releases from Lake O' the Pines, the dam is constructed to only release a maximum of 3,000 cfs (cubic feet per second) of flow from the Ferrell's Bridge Dam. Three other tributaries flow uncontrolled into Caddo Lake and account for approximately 65% of the water that enters Caddo. Two of these streams, Little Cypress Creek and Black Cypress Bayou flowed in excess of 37,000 cfs at their crests into Caddo Lake. The flow rate of these streams was more than twelve times the amount of water released from Lake O' the Pines. These high flow rates were also concentrated in an eight- to nine-week period, whereas the releases from Lake O' the Pines were spread out over six months.

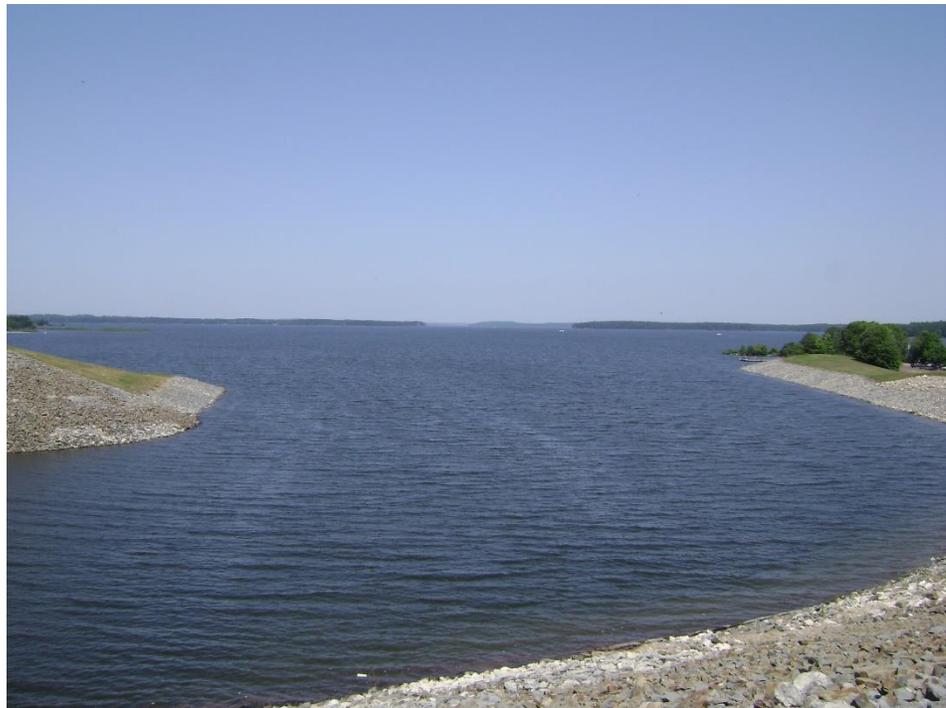
Figure 32: Lake O' the Pines near the Dam

Lake O' the Pines was created by the construction of the Ferrell's Bridge Dam on Big Cypress Bayou. The reservoir was created for flood control after the historic flooding of the City of Jefferson in 1945 and was authorized by the Flood Control Act of 1946. The lake has a total drainage area of 850 square miles with a normal conservation pool of 230 feet MSL. Discharges from the two gates in the control structure vary from a minimum of 5 cfs to a maximum of 3,000 cfs. The storage capacity at 228.5 MSL (Conservation Pool Level) is approximately 254,000 acre-feet.

Despite the historic flooding in 2015 and early 2016, Lake O' the Pines performed its primary function and prevented the City of Jefferson from flooding. Through controlled water releases, over one million acre-feet of water was discharged from the lake between January and August 2016 which was enough water to fill Caddo Lake almost 7 times.

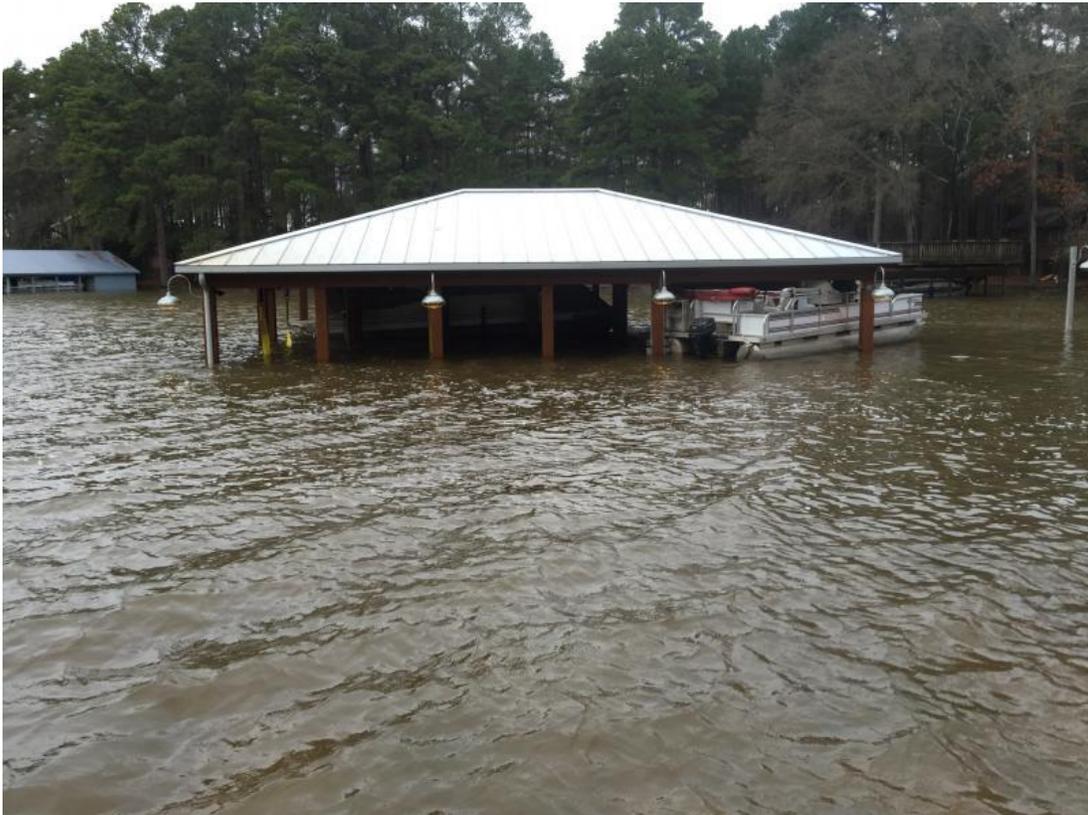
Figure 34: Flooding on Lake Cypress Springs in December 2015

The Franklin County Dam has a fixed spillway structure, which means that when the level of the lake exceeds the normal conservation pool of 378 feet MSL, water flows over the spillway and exits the reservoir. Being a fixed structure also means that Franklin County Water District cannot open gates to release water more quickly during flood events. Heavy rainfall in the area in December 2015 caused extensive flood damage to property surrounding the lake. The lake level peaked at 383.8 feet MSL on December 28, 2015.

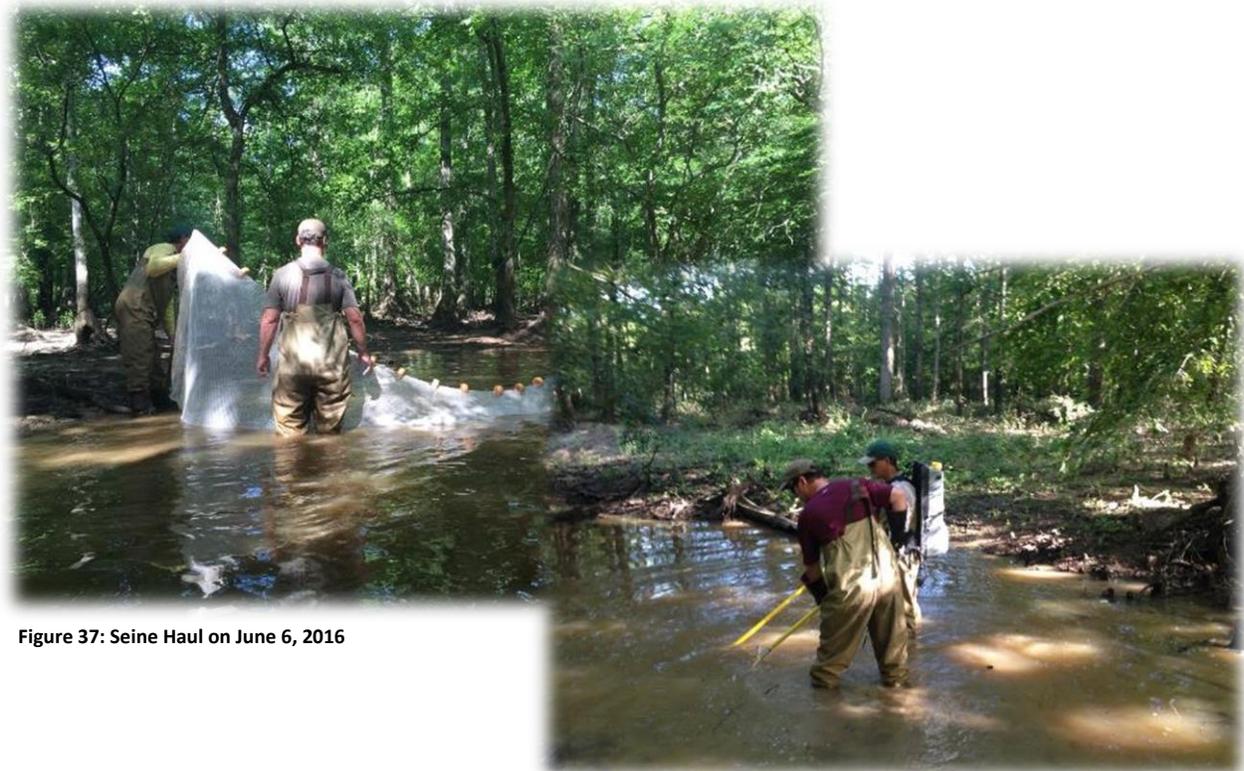
Figure 37: Seine Haul on June 6, 2016

Figure 38: Electroshocking on August 2, 2016

Parameter	June 16	Aug 2
Fish - IBI	37 (Int.)	42 (High)
Benthos - RBA	22 (Int.)	28 (Int.)
Habitat - HQI	15 (Int.)	15 (Int.)
Flow (cfs)	17	0.12

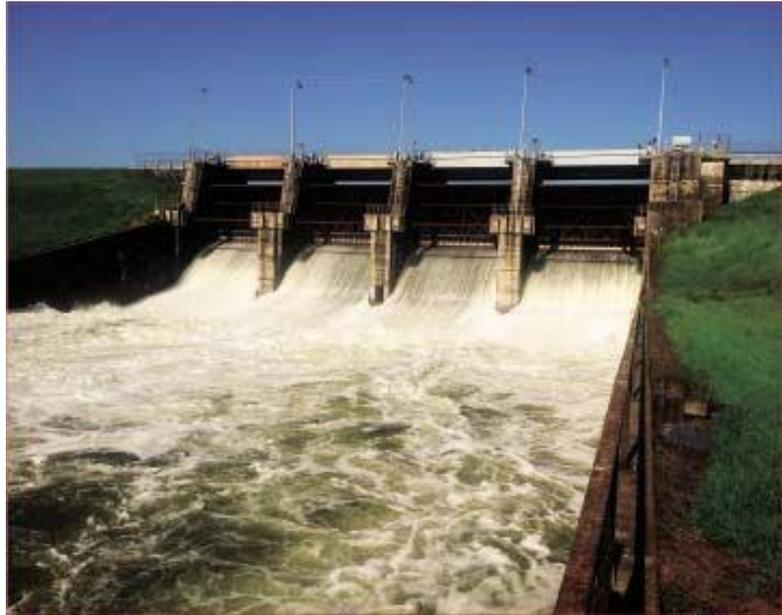
Figure 39: Water Released from the Fort Sherman Dam at Lake Bob Sandlin

Lake Bob Sandlin is located immediately below Lake Cypress Springs and Lake Monticello. The reservoir is a popular recreational and fishing lake. The reservoir is regulated by the Titus County Freshwater Supply District #1. In recent years, many new homes have been constructed along the lakefront.

Extensive flooding throughout the watershed occurred in 2015 through the spring of 2016. A record amount of water was released from the Fort Sherman
